TESTING LABORATORY

TEST REPORT No. 275/10-22. (Hydraulic burst test report of gas cylinders).

Hydraulic static pressure tests until failure of the new metal-composite gas cylinder model CRPIII -106-3.0-30-T manufactured by Liaoning Alsafe Technology Co., Ltd.
Serial number: WF 14020. MFG date: 2021.09. MFG STANDARD: EN 12245.
The sample was delivered by the Customer.
(Nominal internal volume 3.0 l, weight 2.1 kgf, working pressure 300 bar. Hydraulic test pressure 450 bar)

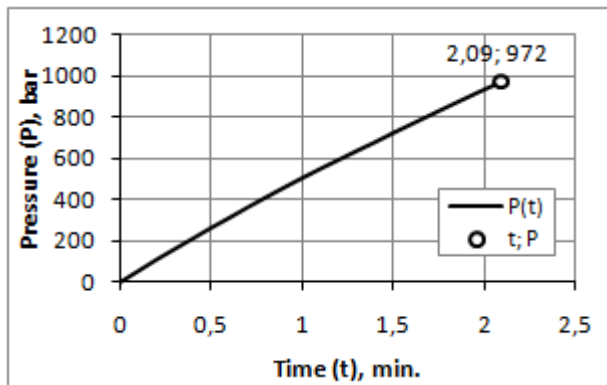
The pressure in the cylinder was increased with a step of 50...100 bar. Load rate 9.0...6.4 bar/s. At each stage there was a hold under pressure for at least two minutes. After loads of 554 and 815 bar the cylinder was kept under pressure of 508 and 526 bar for more than 18 hours. After the exposure, pressure drop and volume change, deformations in the circular and longitudinal directions were not detected.

General diagram of internal pressure load before failure.

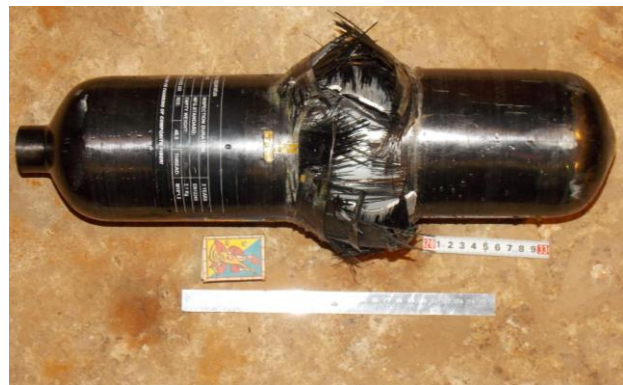
After a load of 911.8 bar, cracks in the lacquer coating in the circular direction were recorded on the cylindrical part of the cylinder.

The cylinder collapsed in the cylindrical part in the longitudinal direction, with plastic deformation of the aluminum liner in the zone of destruction. The destruction took place without debris. Actual burst pressure: 972 bar.

- residual average ring deformation < 0.20 %;
- residual average longitudinal deformation < 0.36 %;
- residual volume change of the cylinder is approximately 32 cm³;
- no remarks on the thread in the neck, on the neck and the bottom.

Photo of cylinder WF 14020 after the tests.

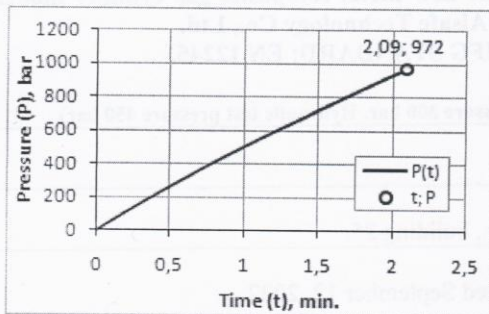
The pressure in the cylinder was increased with a step of 50...100 bar. Load rate 9.0...6.4 bar/s. At each stage there was a hold under pressure for at least two minutes. After loads of 554 and 815 bar the cylinder was kept under pressure of 508 and 526 bar for more than 18 hours. After the exposure, pressure drop and volume change, deformations in the circular and longitudinal directions were not detected.

General diagram of internal pressure load before failure.

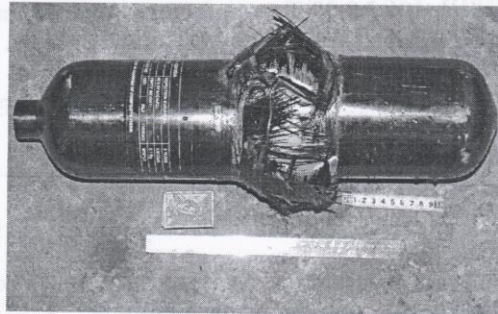
After a load of 911.8 bar, cracks in the lacquer coating in the circular direction were recorded on the cylindrical part of the cylinder.

The cylinder collapsed in the cylindrical part in the longitudinal direction, with plastic deformation of the aluminum liner in the zone of destruction. The destruction took place without debris. Actual burst pressure: 972 bar.

- residual average ring deformation < 0.20 %;
- residual average longitudinal deformation < 0.36 %;
- residual volume change of the cylinder is approximately 32 cm³;
- no remarks on the thread in the neck, on the neck and the bottom.

Photo of cylinder WF 14020 after the tests.
