## EXPERIMENTAL EVALUATION OF TEST BATCH QUALITY OF METAL CYLINDERS USING FULL-SCALE HIGH-PRESSURE HYDRAULIC TESTS. PART 2. RESULTS OF FULL-SCALE CYCLIC TESTS

O. P. Gopkalo,<sup>a,1</sup> R. I. Dmytrienko,<sup>b,2</sup> O. L. Palienko,<sup>b</sup>  
A. E. Lytvynenko,<sup>b</sup> and A. O. Perepichai<sup>b</sup>

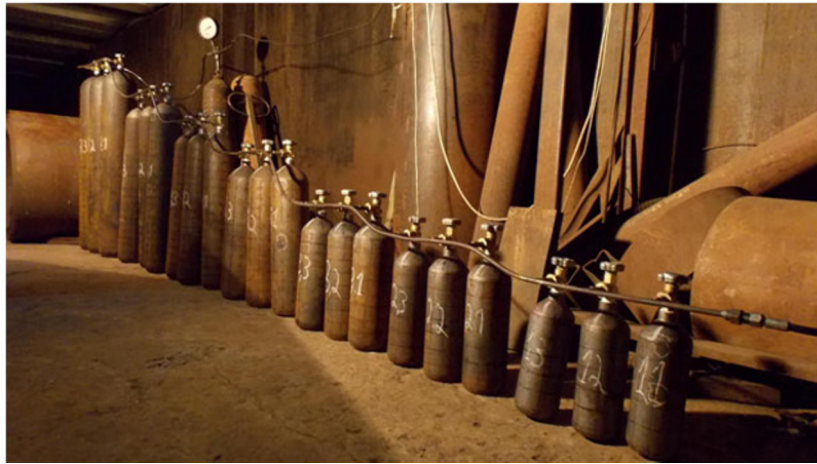
Figure 1 shows the cylinders assembled in a string for cyclic testing with a test pressure of 250 bar.

The actual load parameters are as follows: maximum cycle pressure – 249.5...255.4 bar (average ~252.4 bar), minimum cycle pressure – 15.2...17.7 bar (average ~16.3 bar), cycle range – 231.8...240.2 bar (average ~236.1 bar), temperature of water exiting the system – 25.5...41 °C, cycle duration – 0.3969 min (23.82 s), loading frequency – 2.52 cycles/min (151.16 cycles/h), loading time – approximately 16 s, pressure decay time – approximately 7 s.

Fig. 1. Cylinders assembled in a garland for cyclic testing with test pressure.

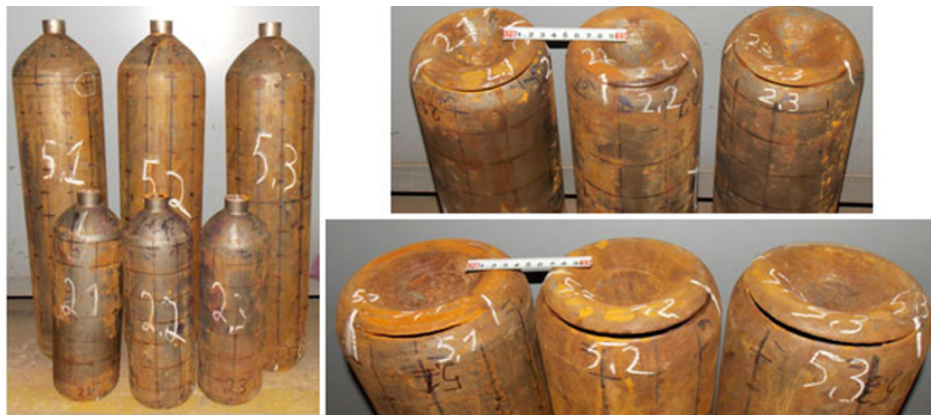
Fig. 3. Photographs of failed cylinders after cyclic hydraulic testing in their initial state and after failure.

Under cyclic loading with a test pressure, failure occurred due to the initiation and propagation of a fatigue crack to critical dimensions in the circumferential direction (low-cycle fatigue failure, Fig. 3) due to the action of longitudinal (axial) stresses, in contrast to static loading, where failure occurred in the longitudinal direction of the cylinder due to hoop stresses. The change in cylinder volume after the first test pressure loading in the water jacket was likely due to irreversible deformation of the bottoms (change in dimension H1, Fig. 4a).
